EVALUATING THE STRUCTURAL AND ARCHITECTURAL DAMAGE OF INHABITANT ISLAMIC STRUCTURES IN CAIRO, EGYPT: A CASE STUDY

Determining the causes of the structural and construction damage, as well as the related responsibilities, and presenting such data that could be used to evaluate the structural damage phenomena to *Takiyya al-Sulaymaniyya*. As will be explained in the following chapters, our strategy was based on a historical and structural evaluation and analyses of the building's structural and construction system, observed damage, building materials, and numerical investigation. *Takiyya al-Sulaymaniyya*

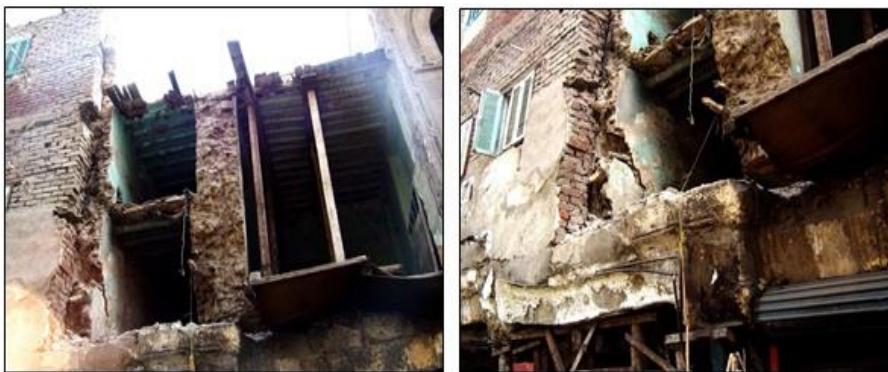
Figure 7: first floor in destroyed current situation.

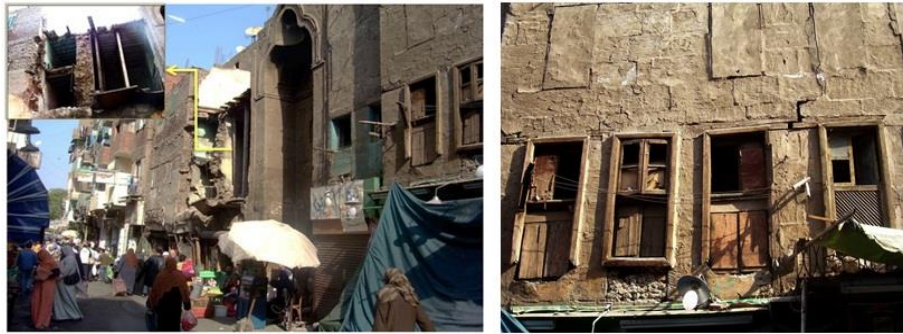
Figure 10: Out-of-plan-failure and cracking in wall 1

From visual observation, it has been established that the *Takiyya al-Sulaymaniyya* suffer significant structural damage in the perimeter masonry walls, such as out-of-plan failure in wall 1 in first floor (main façade), soil settlement and arch thrust, failure in localized regions and large deflections of the bearing members of the roof structure, active deep cracks between perpendicular/vertical walls, collapse of walls and corner wall connections (see Figs 10, 11, and 12) .Beside the above deterioration phenomena there are a lot of inclined cracks distributed in the building structural units, detachment of mortar and wall plaster, damp rise in the walls due to rise of groundwater level under the building, finally due to the daily misused of inhabitants the building suffers a lot of deterioration phenomena. As mentioned above, the building suffers a lot of active cracks in walls and dooms. Cracks were surveyed visually and photographically. The survey campaign revealed a distribution of deep vertical cracks crossing the lime mortar between limestone courses inside and outside of the building.

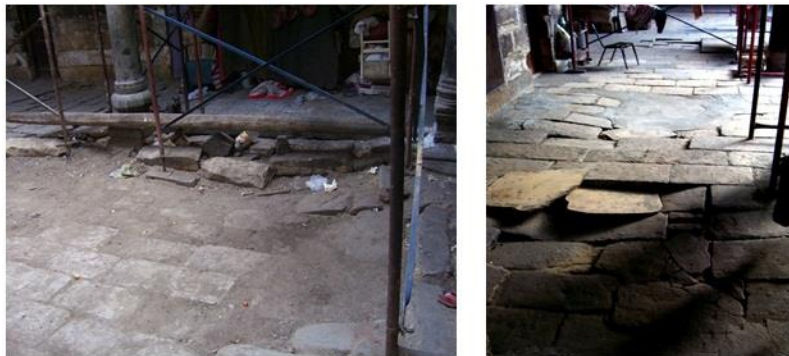
Figure 11: soil settlements

the state of stress and strain applied on the soil under the building foundations to understand the causes of a collapse or settlement.^{16,17,18} One can notice soil settlement clearly in many places inside *Takiyya al-Sulaymaniyya* building (the courtyard and Kiblah Ewan) as shown in Fig. 11. To identify the causes of soil settlement three soil core drilling were made in different settlement points and the results of these soil core drillings shown in table No. 1, 2, and 3. The first soil core drilling "boreholes" shown in table 1 located in the middle of North-east nave, this nave is the most affected one by soil settlement and arch thrust. Soil settlement under the bases of columns supported the arch led to columns moving down in the direction of the settlement and the result is arch thrust.

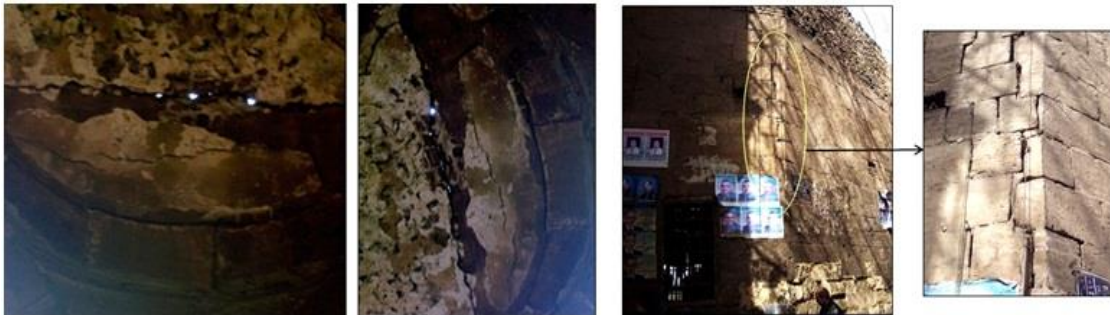
As shown in Fig. 13, the near vertical cracking suffered in the region of the connection of intersecting bearing walls occurred at some distance from the connection itself. Otherwise, dooms suffer active deep cracks as a result of soil settlement. Dooms cracking indicate that the movement of the soil under the columns bases lead to move the columns down towards the settlement which lead to increase the moment in dooms side more than the opposite side leading to increase tensile force rather than tensile strength of mortar and the result is active deep cracks in the dooms as shown in Fig. 13.

Figure 13: Active vertical cracking in dooms and perpendicular walls connection region

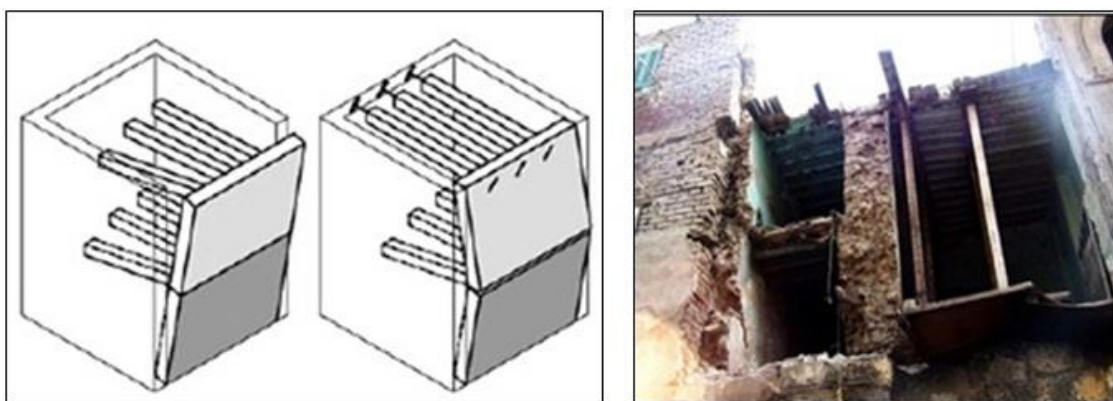
Otherwise, the timber roof is supported on the peripheral walls on short isolated wooden planks not tied together so as to create a bracing system capable of preventing the horizontal displacement of the roof support, which is restrained entirely by friction across the wall width, the latter eventually leading to failure in the form of cracking in wall 1 (main façade) in the first floor. On the other hand, the building built with different kinds of masonry units (stone, semi-fired brick, and Ashlars) at the different stories; as a result, the lateral rigidities of each story differ, and such differences in stiffness and loads increase the risk of failure, and the absence of floor/roof diaphragm increased the out of plan failure as shown in Fig. 14.

Figure 14: out-of-plan failure in wall 1 (main façade) at first floor

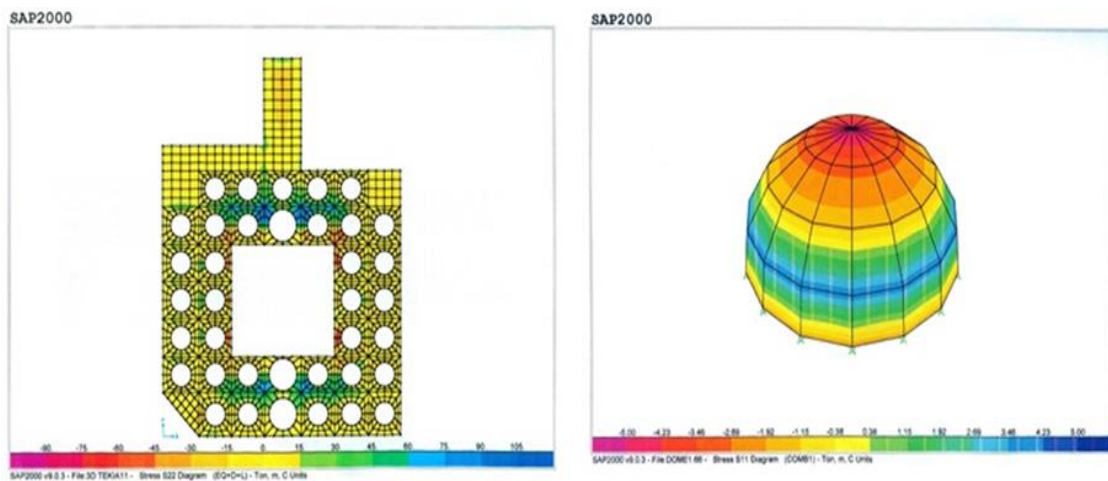
Figure 15: Tensile stresses (in Ton/m²) exceeding the tensile Strength of masonry developing at the critical parts of the roof (area between small and big dooms)

From the evaluation of the current situation of the *Takiyya al-Sulaymaniyya* building and the observed damage and its causes identified both visually and numerically (results of the stress analysis), it can be seen that the building has some positive structural characteristics; however, it also has a large number of structural failures. The positive structural features of the building, such as the ground floor apertures (doors and windows), have been designed with a relatively narrow width and are arranged nearly symmetrically. The building's bearing walls have sufficient thickness to withstand loads and stress. The connection between intersecting walls (large coursed limestone connection) is determined to be sufficiently monolithic. The use of fired bricks in the first floor reduces the loads applied to the walls of the ground floor, and the use of inclined, tiny floor dooms reduces the stresses on the bearing elements. On the other hand, significant shortcomings (structural failures) of the building include faults in the choice of building soil (difficult or filled soil as indicated in tables 1, 2 and 3), the absent or inadequate connected at the intersections of first floor walls and there are no ties or ring beams at the floor and roof levels as shown in Fig. 18, lack of vertical confining element in first floor walls. Otherwise, one of the most structural failures in historic buildings is the lack of diaphragmatic action at the levels of floors and roof that would contribute to the monolithic response of the building under seismic excitation; finally, the lack of bracing at the wall crowning has a negative effect at the bearing wall-roof interaction. Masonry, in structural point of view, exhibits high load-carrying capacity in compression but in the same time it is much lower capacity in tension. In *Takiyya al-Sulaymaniyya* building large spans are covered by using domes that allow forces to be transferred in compression. These masonry domes, typically found in a state of structural distress appearing in the form of cracking as shown in Fig. 13. Cracks in the dooms due to the development of tension stresses in the top of the dooms because of the effect of soil settlement under the bearing columns bases that created additional tensile forces exceeding the tensile strength of its building materials. The tensile stresses developing at the main façade wall under the design loading conditions were found to exceed the tensile strength of the masonry. This explains the causes of the cracking observed in the building, attributed to the lack of a bracing system to prevent the horizontal displacement of the wooden roof. In *Takiyya al-Sulaymaniyya* building, in spite of using larger limestones at the corners, in order to provide an appropriate connection between the perpendicular walls, Atfit-El-Limon intersecting bearing walls suffered active vertical cracking occurred in the region of the connection itself as shown in Fig.13. Intersecting bearing walls cracking in this region confirms that the region exposure to forces (tensile failure) exceeded the resistance forces to protect these corners from cracking. On the other hand, Figs. 16 to 18 show the high value of tensile stresses in the courtyard wall crowing which exceed the tensile strength of its building materials, this high value of tensile stresses due to the movement of soil (soil settlement) under the columns bases and the presence of many heavy dooms adjacent to courtyard wall crowing (see Fig. 9). Otherwise bearing walls

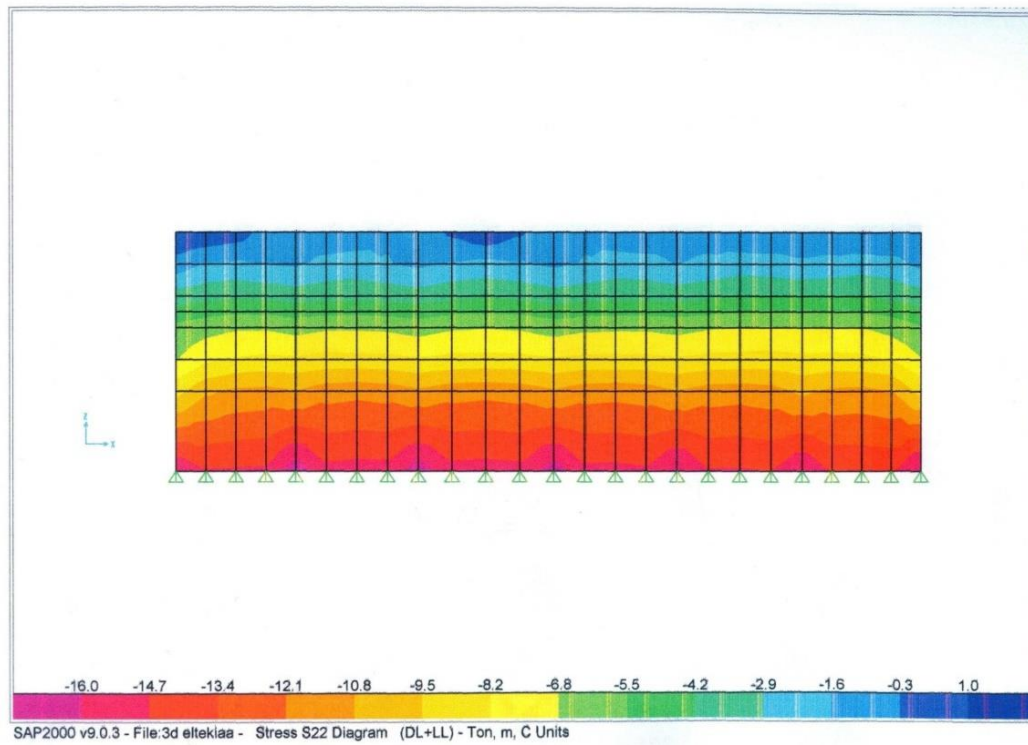
Figure 16: shows the tensile stresses (in Ton/m) exceeding the tensile strength of masonry developing at the wall crowning and the high value of compressive

in the building suffered high value of stresses upon them as shown in 16, 17 and 18 the values of the stresses varying from 18 to 20 Ton/m². The presence of underground water under the building (in the depth of -1m as described before) with the help of high percentage of pore size of the limestone used in the building the moisture transfers rapidly both vertically and horizontally to limestone (height of moisture movement). So we can conclude that the main causes of the unsatisfactory or poor resistance of the masonry walls in Takiyya al-Sulaymaniyya are the poor physical properties and the presence of under groundwater that contributing to the deterioration of the building limestone through rising damp followed by salt weathering phenomenon. This phenomenon leads to one outcome type before the effect (alternative hydration and crystallization cycles) and another type after it (full disintegration mechanisms and forms). From observed damages and the methods of damage assessments (material properties and numerical analysis) we can conclude that the significant shortcoming of Takiyya al-Sulaymaniyya building is the lack of diaphragmatic action at the levels of floors and roof that would contribute to the monolithic response of the building under seismic excitation. Another shortcoming is the use of heavy domes which increase the likelihood of stresses upon the bearing walls.

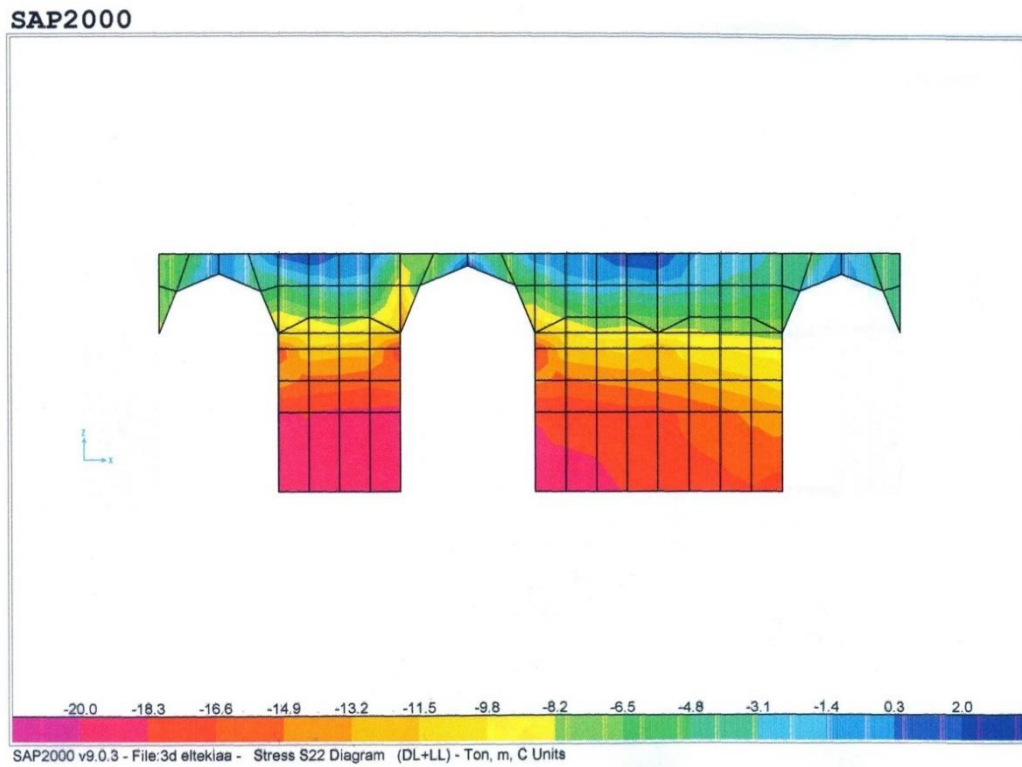
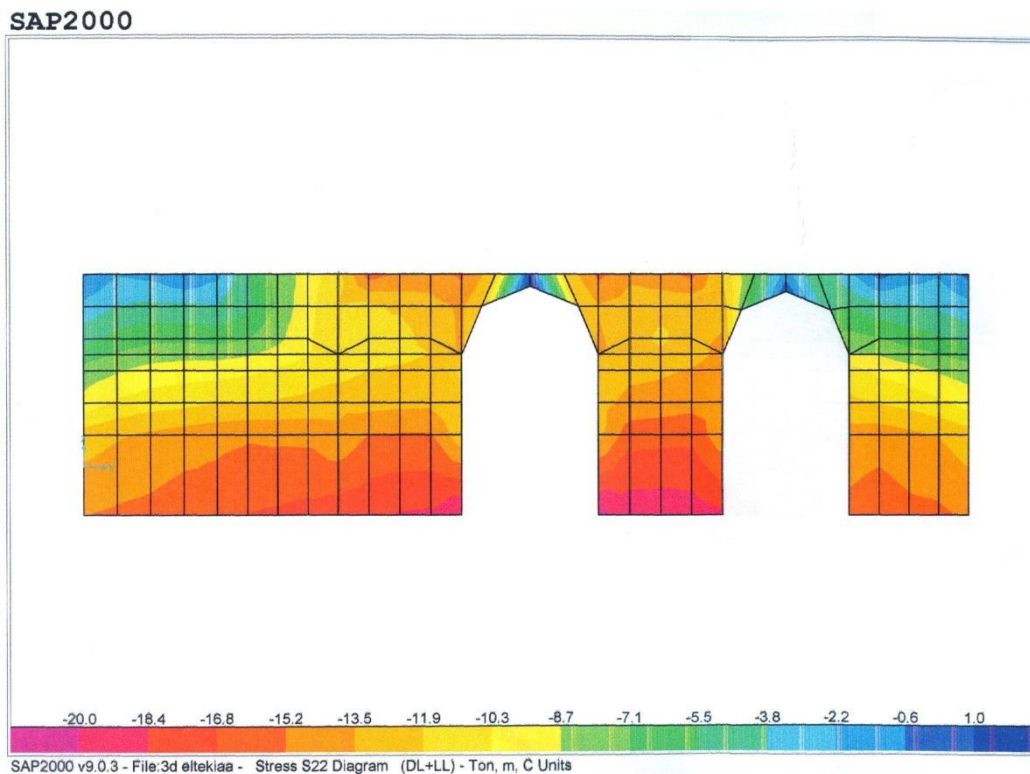
Figure 17: Tensile and compressive stresses (in Ton/m) where tensile stresses exceeding the tensile strength of masonry developing in the region upon the arches and wall crowing. The compressive strength exceeding in the lower part of the wall between the two arches.

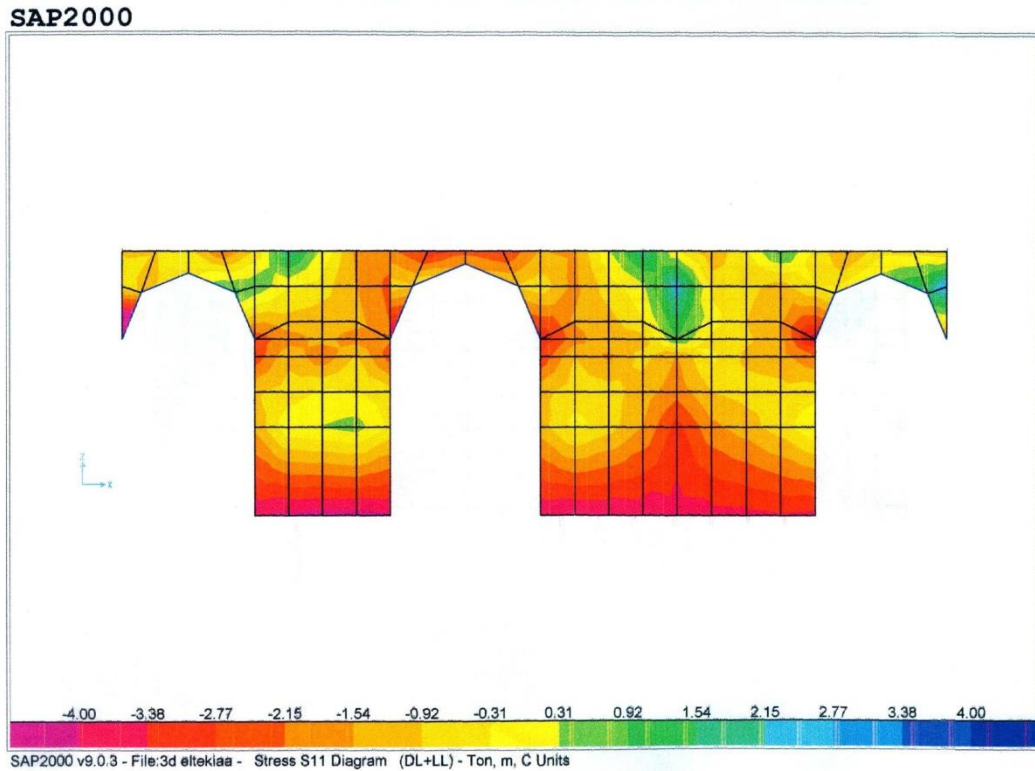
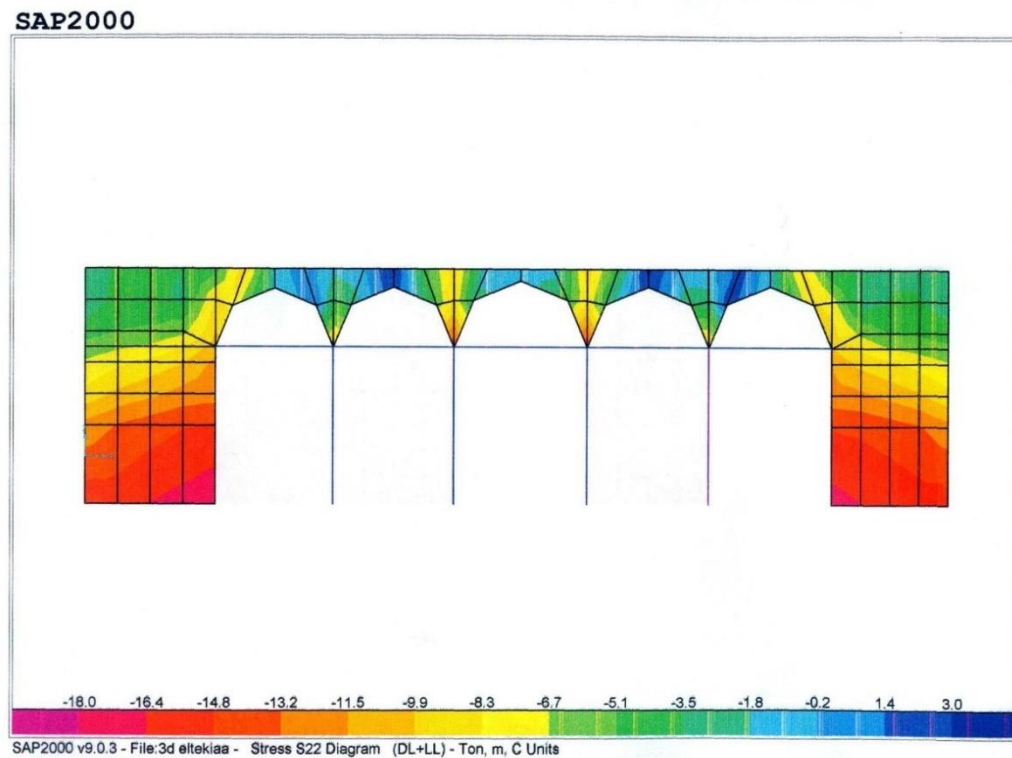
Figure 18: shows the result of tensile and compressive stresses (in Ton/m) in arches Takiyya al-Sulaymaniyya building. Tensile stresses in arches exceeding the tensile strength of its building materials, the same in the wall crowing.
