EVALUATING THE STRUCTURAL AND ARCHITECTURAL DAMAGE OF INHABITANT ISLAMIC STRUCTURES IN CAIRO, EGYPT: A CASE STUDY

Determining the causes of the structural and construction damage, as well as the related responsibilities, and presenting such data that could be used to evaluate the structural damage phenomena to *Takiyya al-Sulaymaniyya*. As will be explained in the following chapters, our strategy was based on a historical and structural evaluation and analyses of the building's structural and construction system, observed damage, building materials, and numerical investigation. *Takiyya al-Sulaymaniyya*

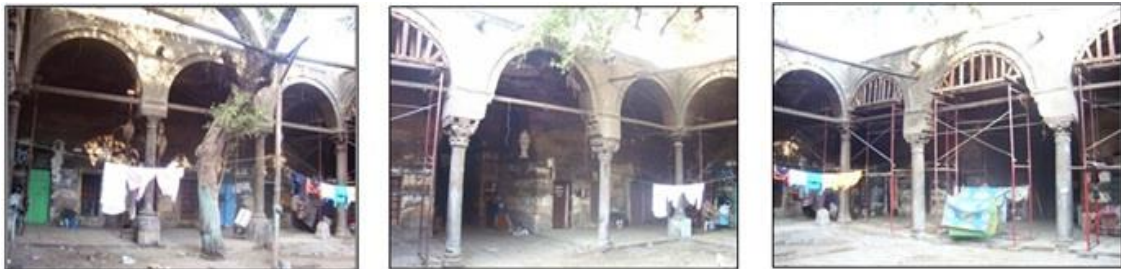
On the other hand, the plan of *Takiyya al-Sulaymaniyya* looks like mosque plan as it contains Mehrab (niche or sanctuary) and Minber (rostrum) for pray. Otherwise, *Takiyya al-Sulaymaniyya* has in front of its main façade 6 small shops called in Arabic *Hawaneet* used in commercial purposes.⁸ Over the years, the building was used as a shelter for accommodation of poor people. Henceforth the building remained completely forlorn and derelict. As a result of the long period of neglect and lack of maintenance it has sustained damages to a considerable extent.⁹

Figure 4: show some of inhabitants' activity inside the building.

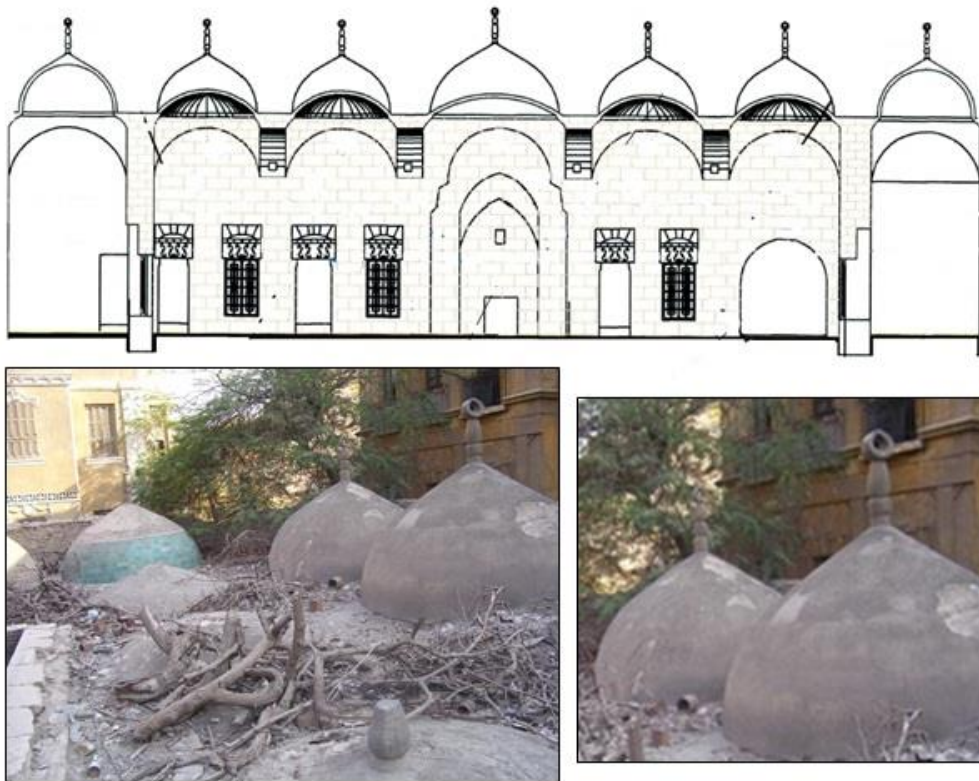
Figure 9: ground floor domed roof (semi-circle and inclined domes)

From the evaluation of the current situation of the *Takiyya al-Sulaymaniyya* building and the observed damage and its causes identified both visually and numerically (results of the stress analysis), it can be seen that the building has some positive structural characteristics; however, it also has a large number of structural failures. The positive structural features of the building, such as the ground floor apertures (doors and windows), have been designed with a relatively narrow width and are arranged nearly symmetrically. The building's bearing walls have sufficient thickness to withstand loads and stress. The connection between intersecting walls (large coursed limestone connection) is determined to be sufficiently monolithic. The use of fired bricks in the first floor reduces the loads applied to the walls of the ground floor, and the use of inclined, tiny floor dooms reduces the stresses on the bearing elements. On the other hand, significant shortcomings (structural failures) of the building include faults in the choice of building soil (difficult or filled soil as indicated in tables 1, 2 and 3), the absent or inadequate connected at the intersections of first floor walls and there are no ties or ring beams at the floor and roof levels as shown in Fig. 18, lack of vertical confining element in first floor walls. Otherwise, one of the most structural failures in historic buildings is the lack of diaphragmatic action at the levels of floors and roof that would contribute to the monolithic response of the building under seismic excitation; finally, the lack of bracing at the wall crowning has a negative effect at the bearing wall-roof interaction. Masonry, in structural point of view, exhibits high load-carrying capacity in compression but in the same time it is much lower capacity in tension. In *Takiyya al-Sulaymaniyya* building large spans are covered by using domes that allow forces to be transferred in compression. These masonry domes, typically found in a state of structural distress appearing in the form of cracking as shown in Fig. 13. Cracks in the dooms due to the development of tension stresses in the top of the dooms because of the effect of soil settlement under the bearing columns bases that created additional tensile forces exceeding the tensile strength of its building materials. The tensile stresses developing at the main façade wall under the design loading conditions were found to exceed the tensile strength of the masonry. This explains the causes of the cracking observed in the building, attributed to the lack of a bracing system to prevent the horizontal displacement of the wooden roof. In *Takiyya al-Sulaymaniyya* building, in spite of using larger limestones at the corners, in order to provide an appropriate connection between the perpendicular walls, Atfit-El-Limon intersecting bearing walls suffered active vertical cracking occurred in the region of the connection itself as shown in Fig.13. Intersecting bearing walls cracking in this region confirms that the region exposure to forces (tensile failure) exceeded the resistance forces to protect these corners from cracking. On the other hand, Figs. 16 to 18 show the high value of tensile stresses in the courtyard wall crowing which exceed the tensile strength of its building materials, this high value of tensile stresses due to the movement of soil (soil settlement) under the columns bases and the presence of many heavy dooms adjacent to courtyard wall crowing (see Fig. 9). Otherwise bearing walls

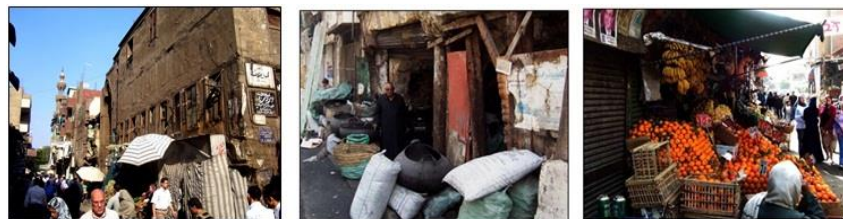
Figure 12: Daily trade activity in EL-Tikia EL-Solimania shops
